Technical Note

Client: Kingston District Council

Subject: Wyomi Beach seawall – immediate term adaptation options assessment

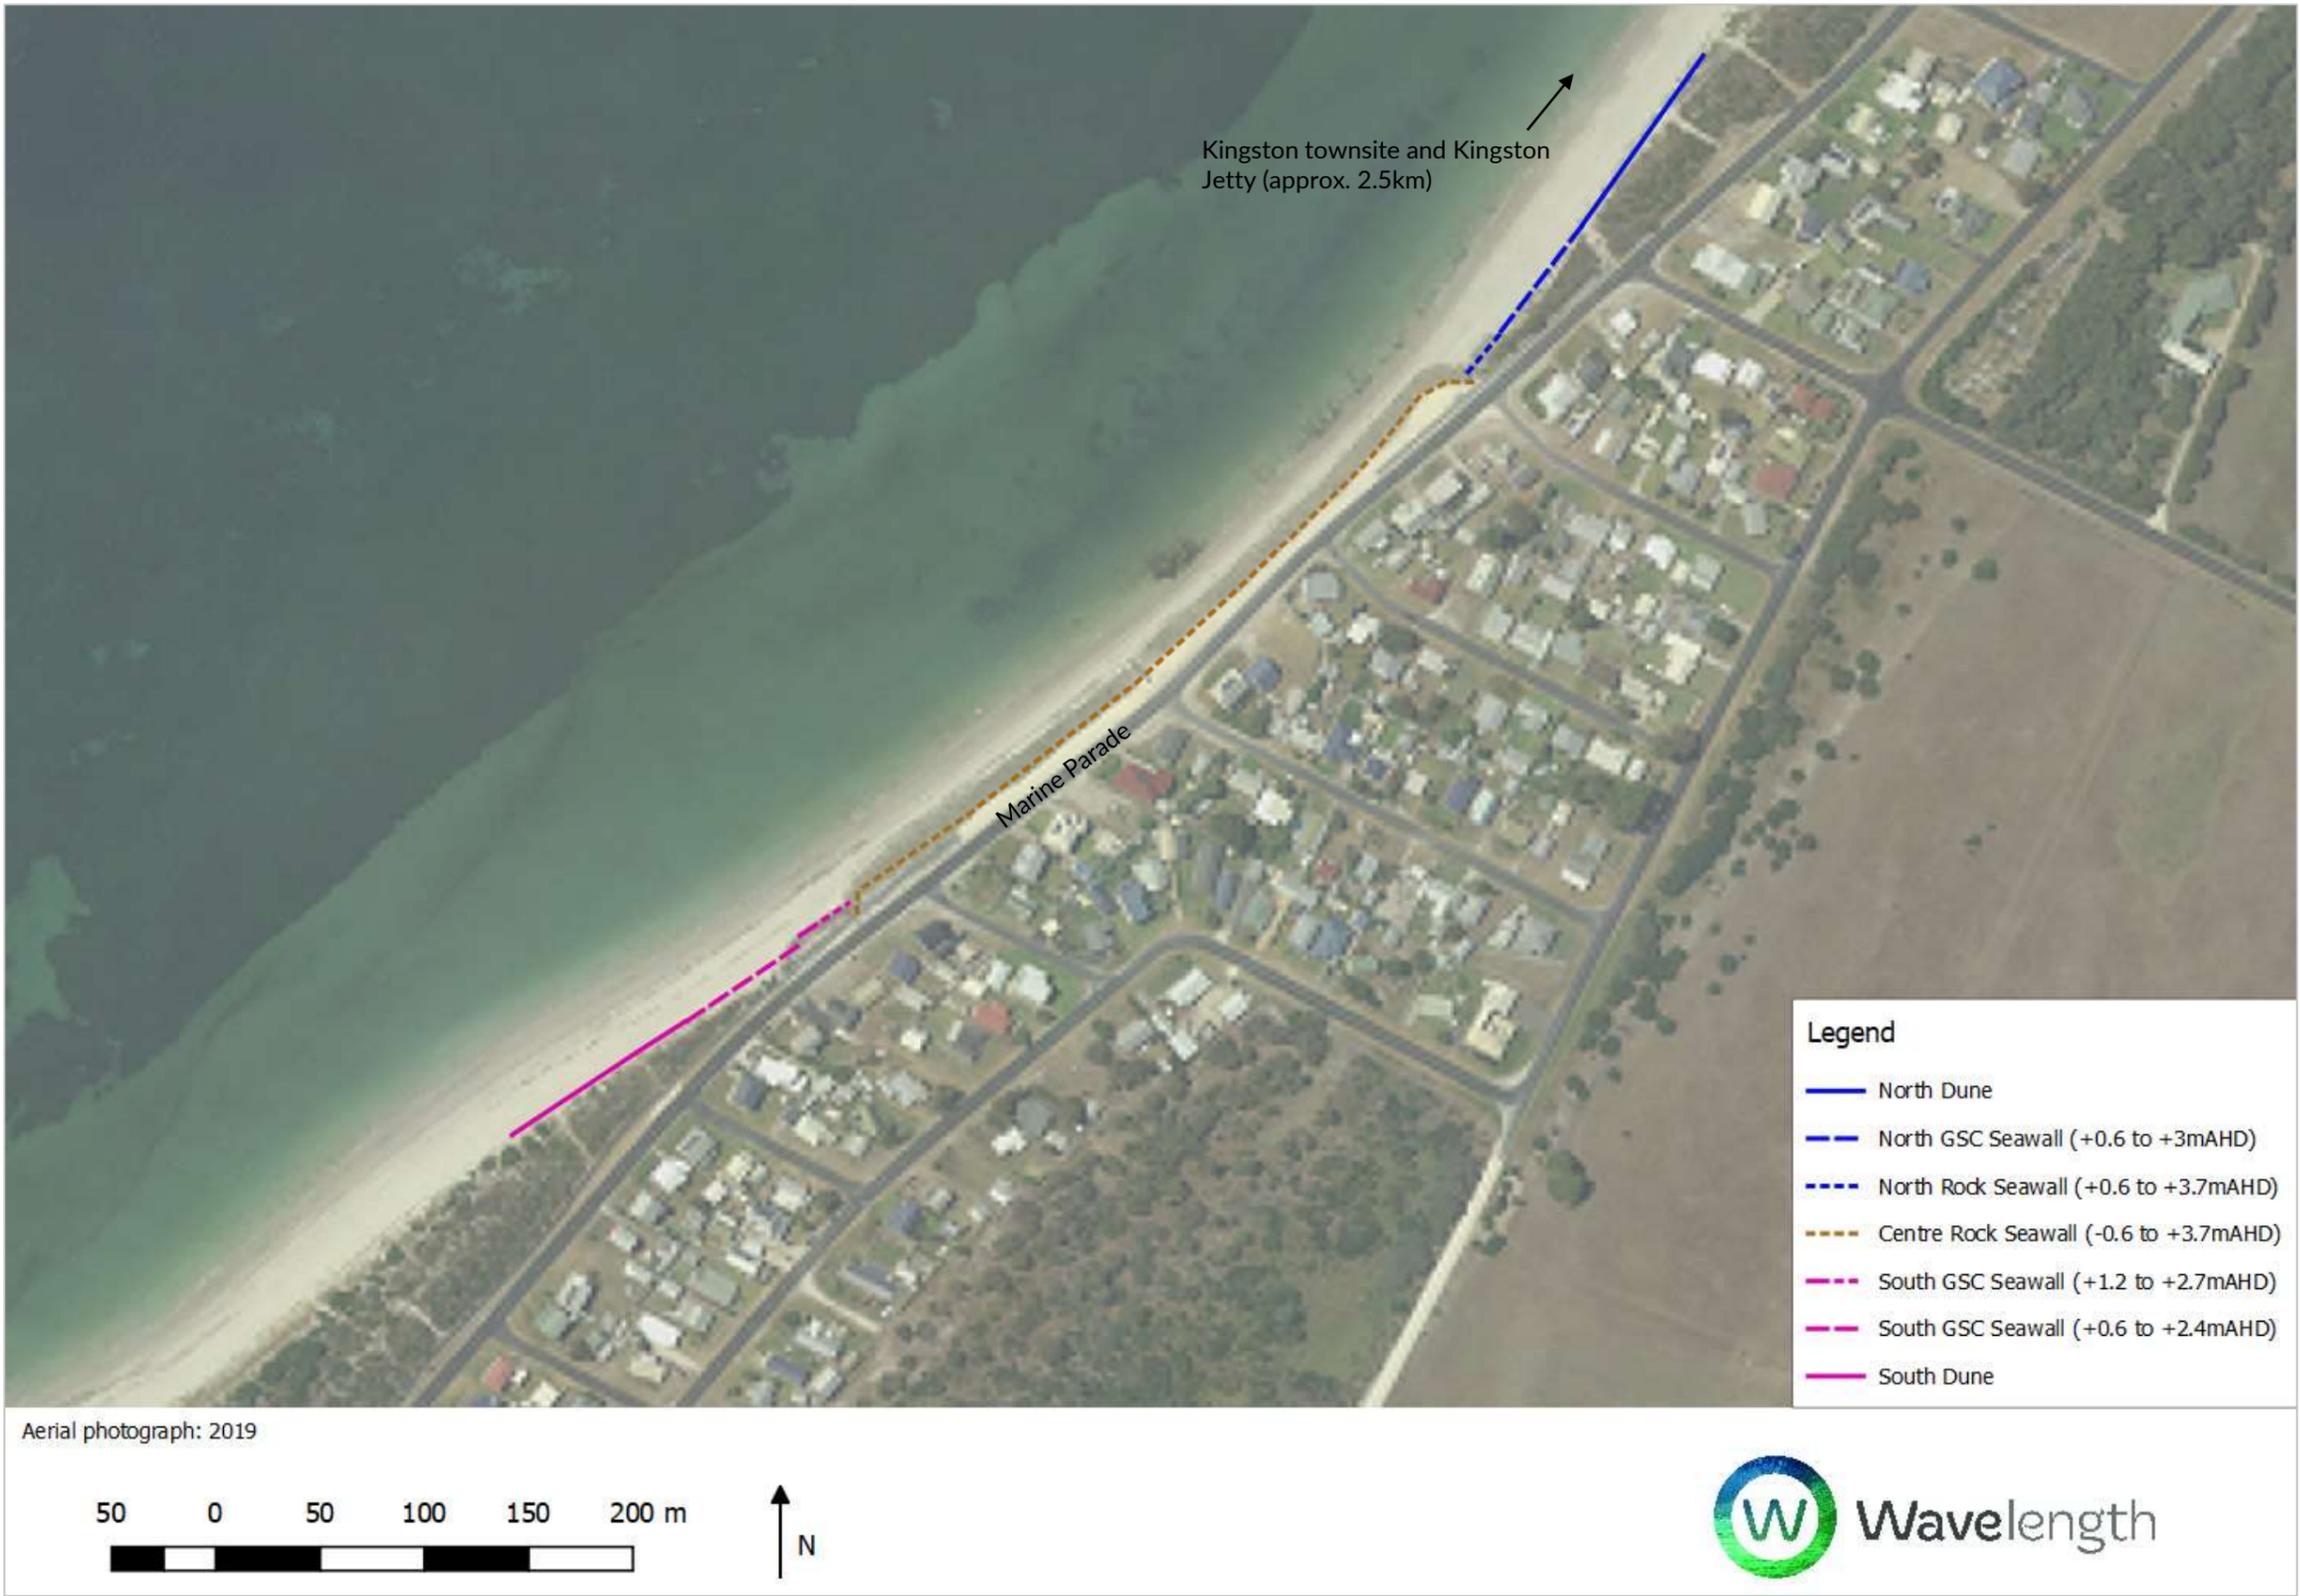
Figure 1: Wyomi Beach study area & existing structures

The Wyomi shoreline can be separated into 3 distinct compartments outlined below and as shown in Figure 1:

- South (pink area)
- Central (brown area)
- North (blue area)

These three areas will be referred to throughout this technical note. The study area extends approximately 100m north and south of the existing GSC seawalls and the existing coastal protection structures have a range of foundation and crest levels, as summarised in Table 1 and presented in Figure 1.

The design storm event was applied to the dune and seawall locations previously presented in Figure 1. An example plot of the modelled erosion for the north dune profile is presented in Figure 10.

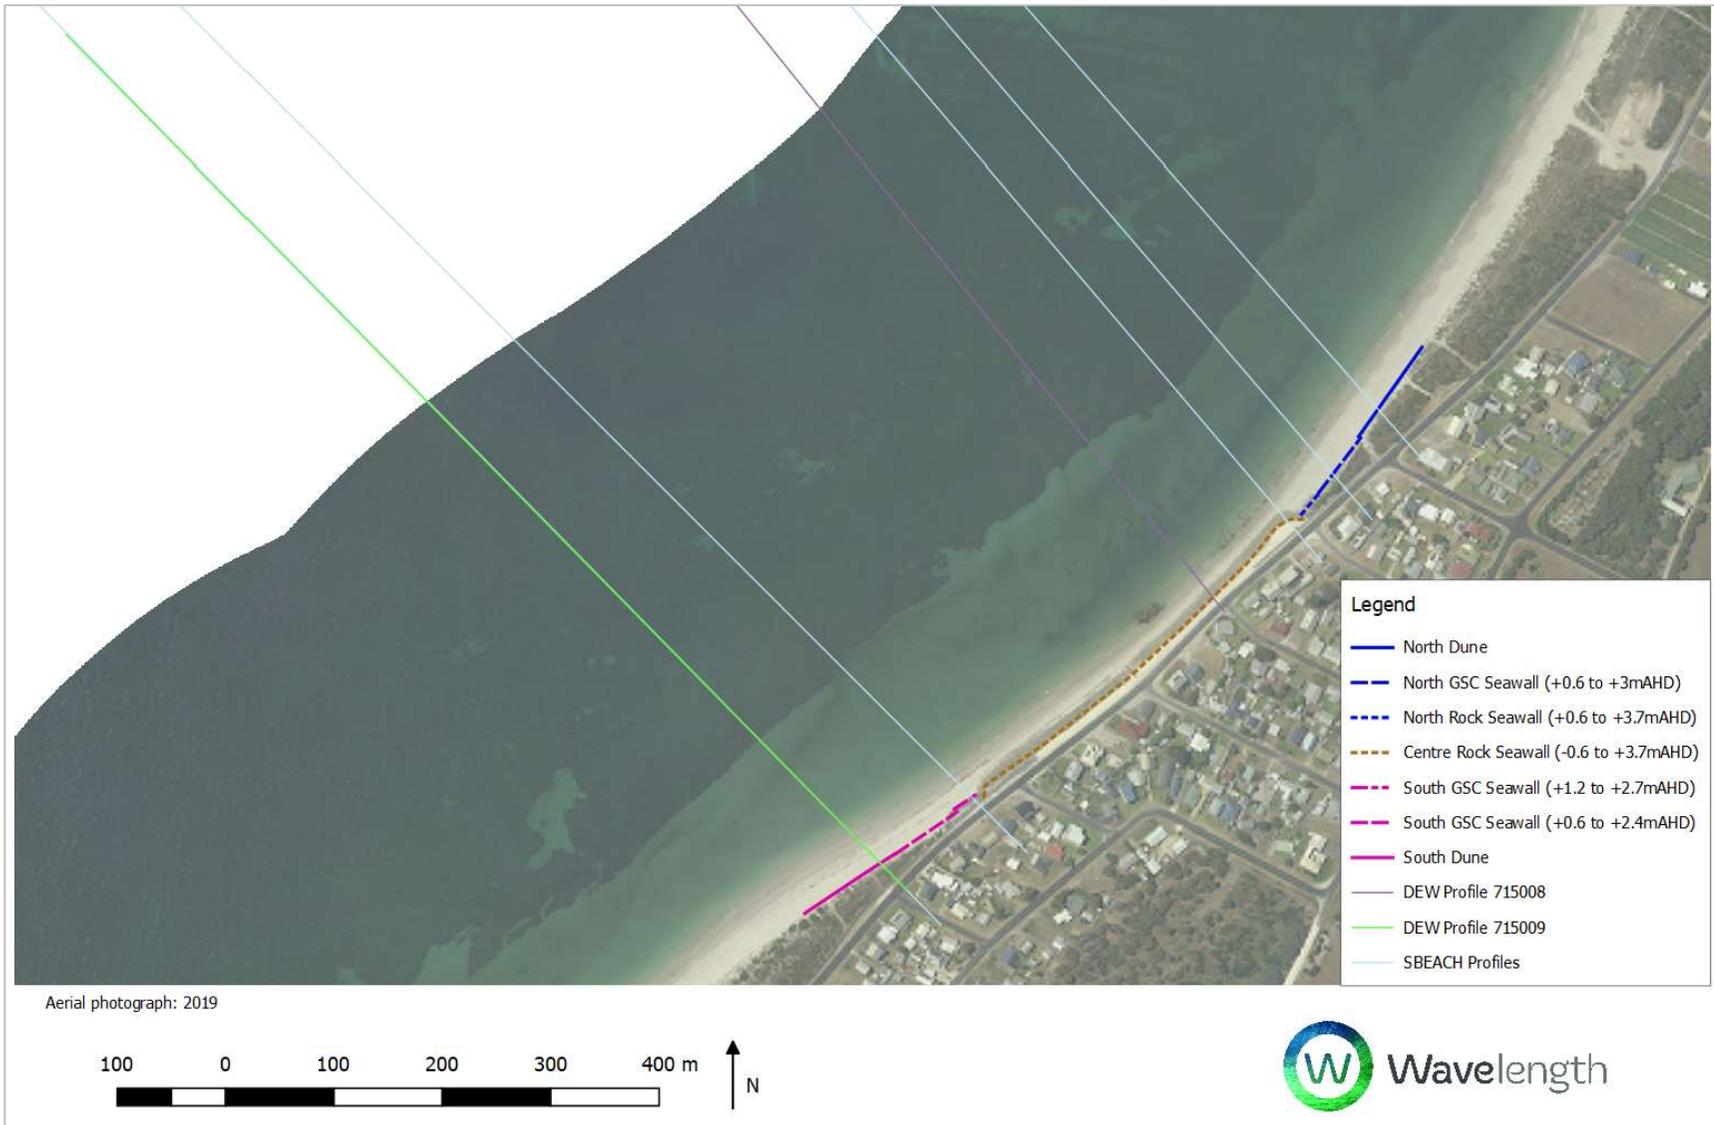
Figure 2: DEW profile locations

- Site measurements of beach levels (relative to existing structure levels) by senior coastal engineer's site visit on the 21/2/2020.
- Beach and nearshore profiles 715008 and 715009 collected by Department of Environment and Water (DEW). These extend from the rear of Marine Parade to approximately -5mAHD contour, as shown in Figure 2 on the following page. The latest survey from April 2018 was used for the present day beach profiles and were found to match well with site observations of beach slope and height.

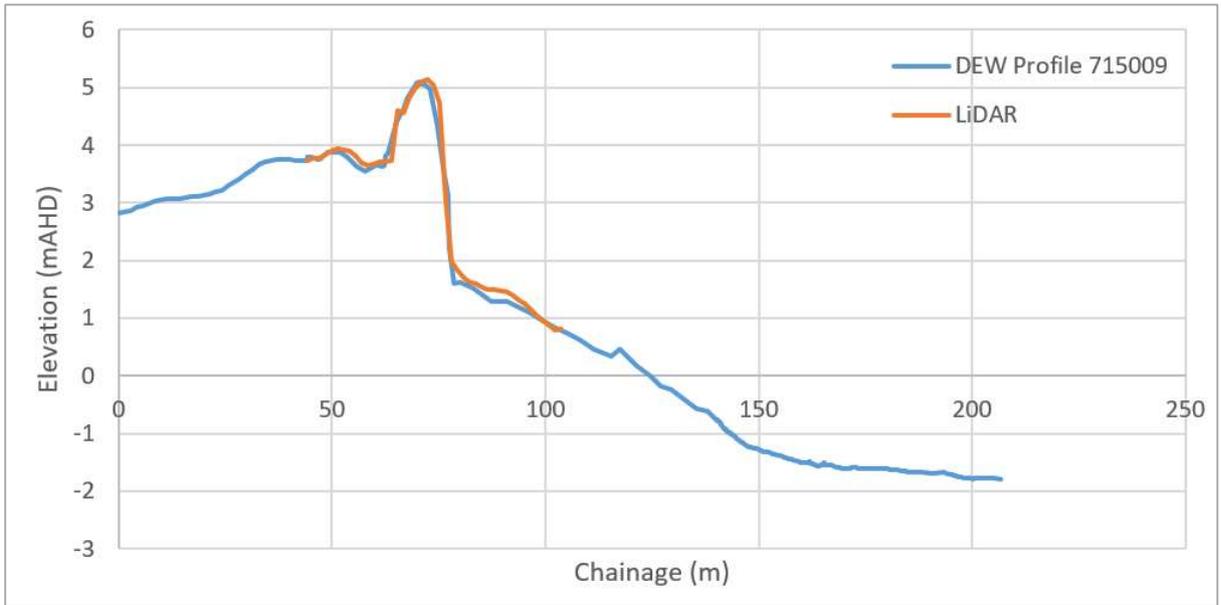
Figure 3: Comparison of LiDAR and DEW profile 715009

- LiDAR Digital Elevation Model (DEM) data from October 2018 was used to fill in the beach and onshore topography between the DEW profiles. The LiDAR and DEW profiles were found to match well, as shown in Figure 3.

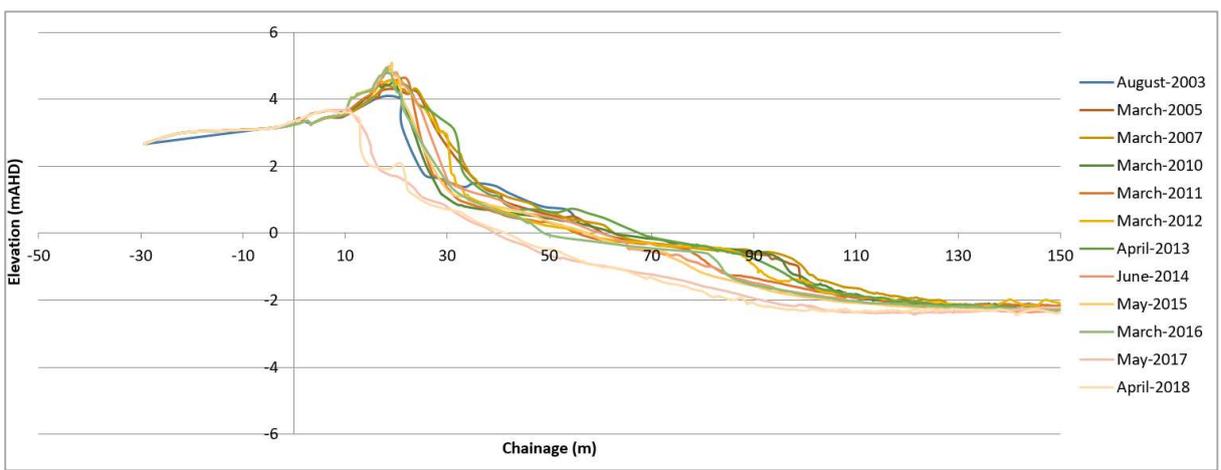
Figure 4: DEW profile 715008 since 2003

As noted in Section 2.1, the design storm for assessment of immediate adaptation options is in the order of 20 to 50 years ARI. DEW have been monitoring the shoreline at Wyomi at approximately 1 to 3 year intervals since 2003, as shown in Figure 4

The largest erosion recorded during this approximate 20 year period was between March-2016 and May-2017, with approximately 10 to 15m of dune width lost. Most of this erosion is likely to have

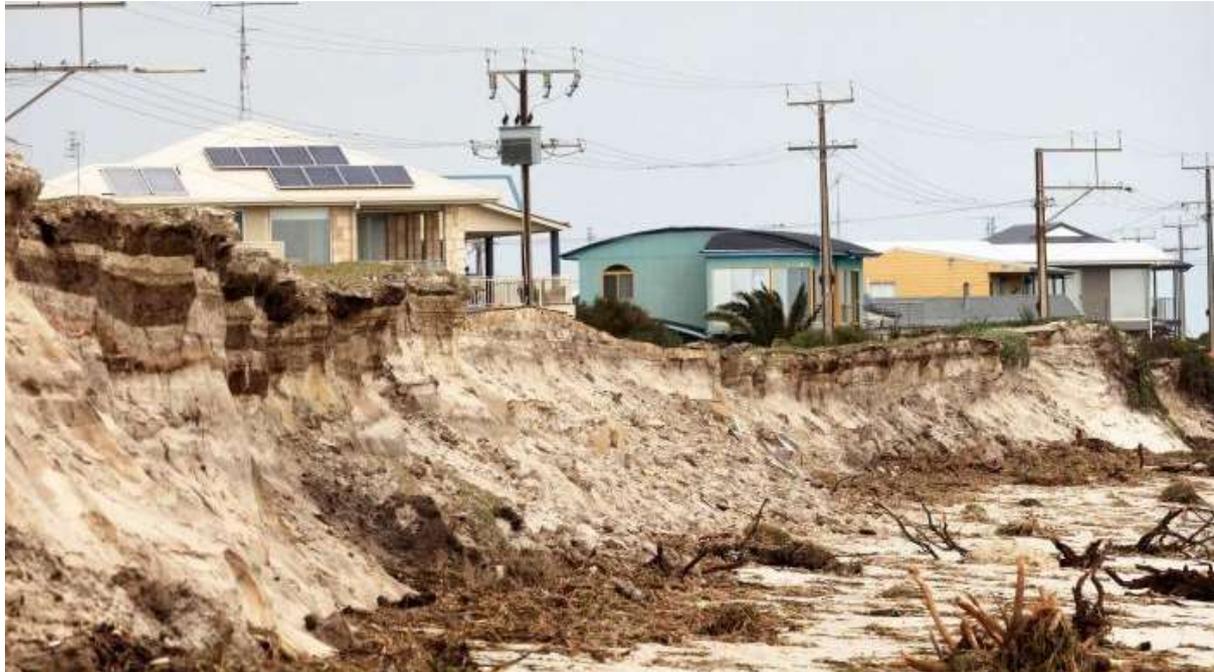
Figure 5: 15th July 2016 storm erosion photograph (ABC News, 2016)

occurred during a large storm event between 10th and 13th July 2016. This storm was reported to have damaged the Kingston jetty and Maria Creek breakwaters (Pers. Comm. David Worthley, 21 February 2020), as well as causing significant beach erosion at Wyomi, as shown in Figure 5 (ABC News, 2016).

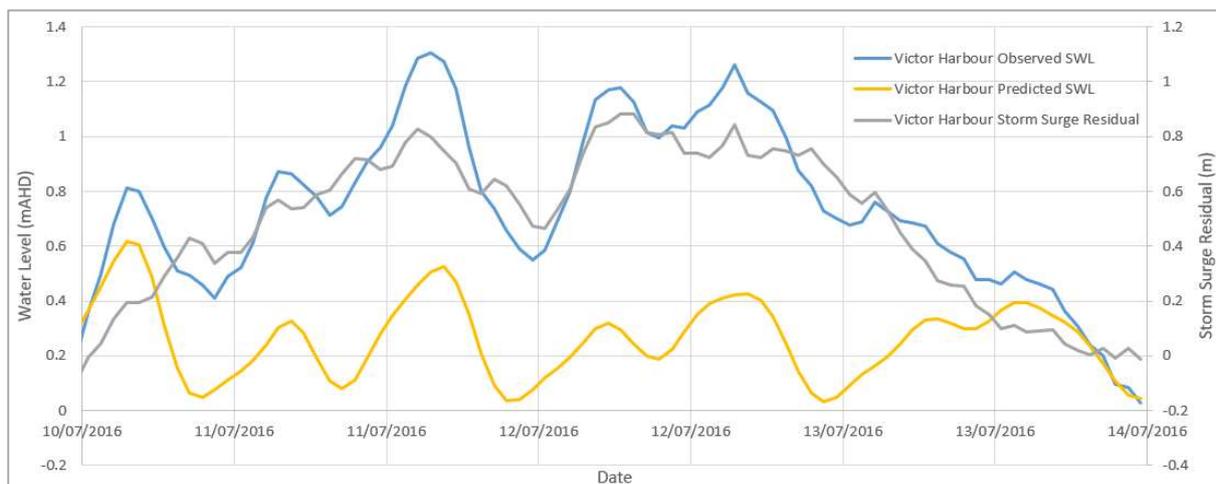
Figure 6: Victor Harbour water level observations

Water levels during the storm event were recorded at Victor Harbour, located approximately 170km north of the study site, presented in Figure 6.

Figure 6 shows the July 2016 storms had two water level peaks due to the passage of two winter cold fronts in close succession. This event had elevated water levels for a 72-hour period, coinciding with a period of spring high tides (Mean High Water Springs at Victor Harbour is approx. +0.6mAHD). The water level peaked at an approximate 5 year ARI water level for the Victor Harbour tide gauge (Pattiaratchi, C. et al 2018).

The input water levels from Victor Harbour (Figure 6) and wave heights from Cape du Couedic (Figure 7) were input to the SBEACH model with the pre-storm profile taken from the March-2016 DEW profiles 715008 and 715009. The missing wave data from the Cape du Couedic was synthesised to peak at a wave height of 7m with the passage of the first storm front, given that this was less severe than the second storm front based on the recorded storm surge residuals.

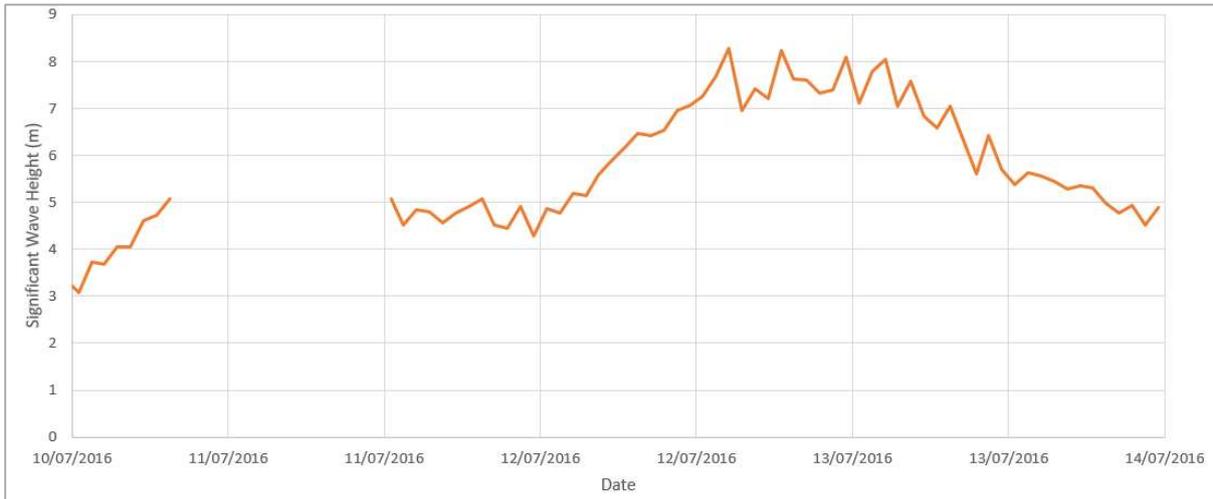
Figure 7: Cape du Couedic wave observations

The waves recorded offshore at Cape du Couedic wave rider buoy (south-west of Kangaroo Island) in approximately 80m water depth are presented in Figure 7.

The July 2016 storms had a peak wave height of approximately 8.2m, which corresponds to an approximately 10 year ARI offshore wave height (WRL, 2013).

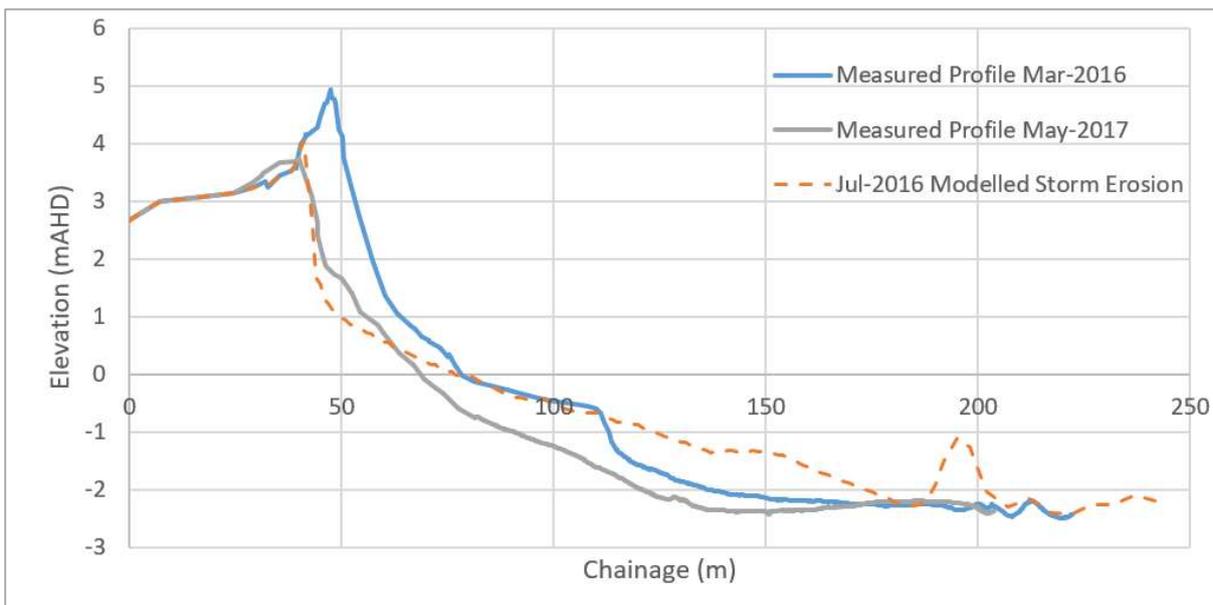
Figure 8: DEW Profile 715008 model testing results

The results of the model testing are shown in Figure 8 and Figure 9.

The modelled dune erosion widths match the measured post-storm (May-2017) profiles well. There has been some loss of material at depth (>-1mAHD) but this is likely due to longshore transport losses that occur naturally through coastal processes, including during severe storm events. These results provide confidence in the model inputs for testing various erosion scenarios at Wyomi Beach. As such, the July 2016 storm was input as the design storm event in the SBEACH modelling.

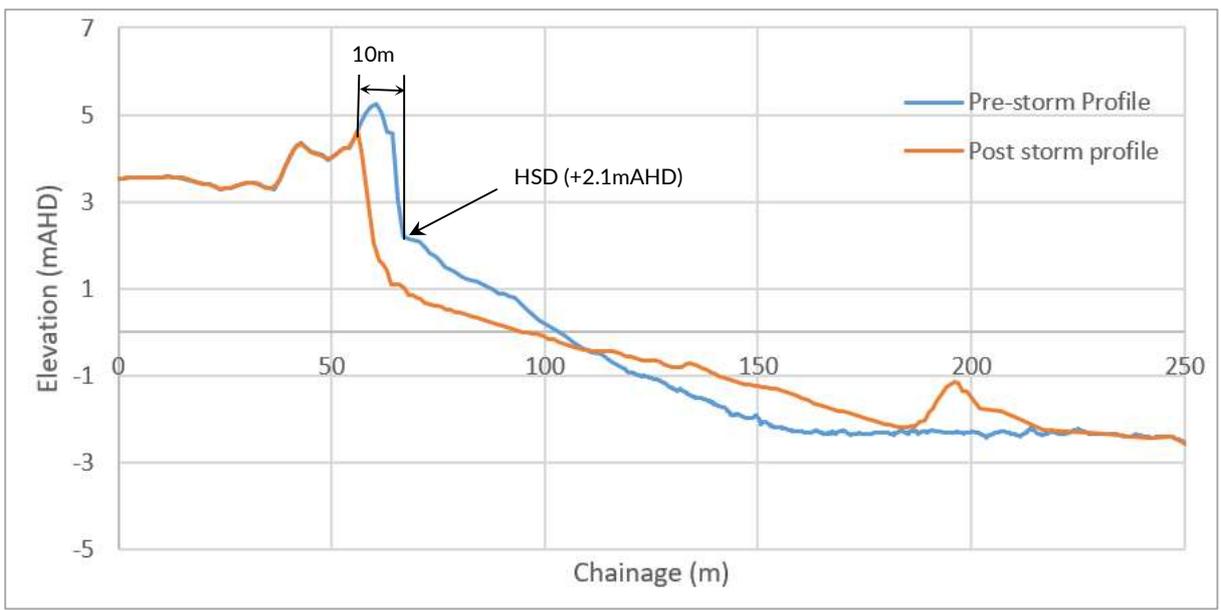
Figure 10: Example SBEACH results (north dune)

Where seawalls exist on the profile, a hard bottom profile was added in SBEACH to model potential scour depth at the seawall toe. Scour calculations, using the methodology of Xie (1981), were also completed to cross-check erosion depths. Wave runup was also output from SBEACH for comparison to crest levels and width for determination of overtopping risk. These results are summarised in Table 3 on the following page. Erosion hazard lines are presented in the following Section 3.

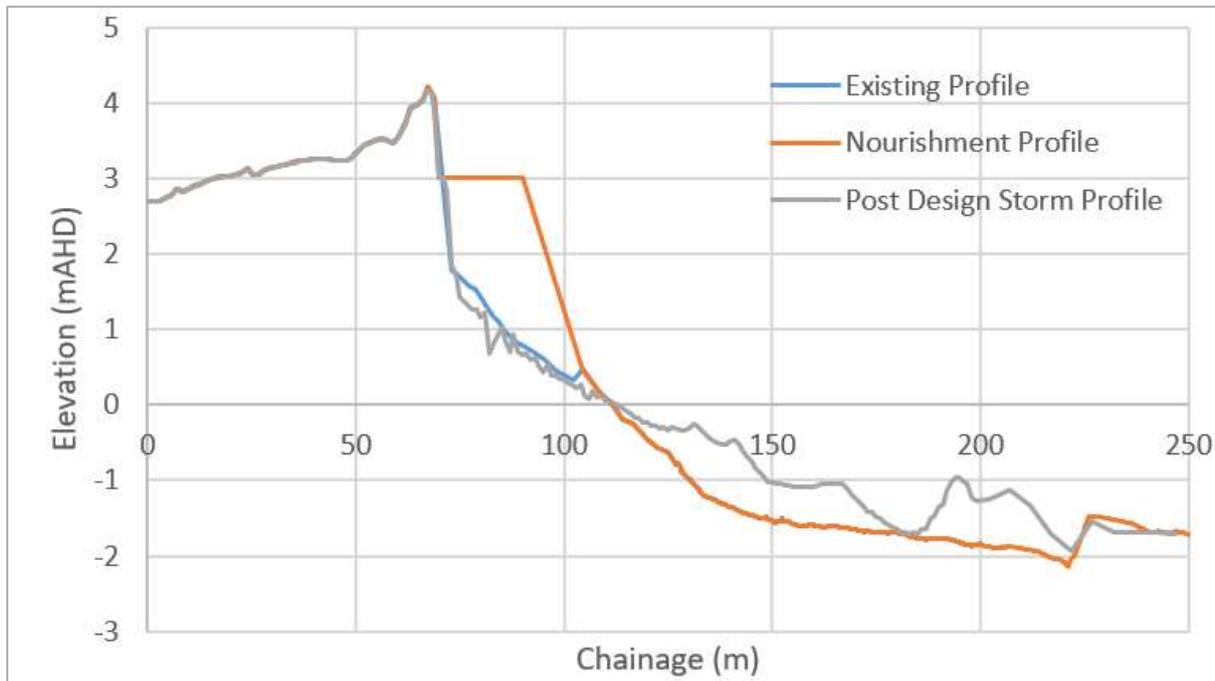
Figure 13: South compartment nourished profile & post storm profile

A nourished berm 20m wide at +3mAHD, with a front slope of 1V:5H would provide the necessary volume and could be placed above 0mAHD. The nourished berm was input with the July 2016 design storm in SBEACH. The erosion modelling results for the southern compartment are presented in Figure 13.

Figure 13 shows that erosion during the design storm event does not expose the existing GSC seawall, with similar results obtained in the northern compartment.

- In the southern compartment, placement of approximately 7,200m³ (in situ volume) sand at an estimated cost of \$120,000 would be required to protect the 90m long Very High risk shoreline. The recommended nourishment has a total length of 120m and includes an additional 30m allowance on the southern (downdrift) side of the GSC seawalls. The recommended extent of nourishment is shown in Figure 13.

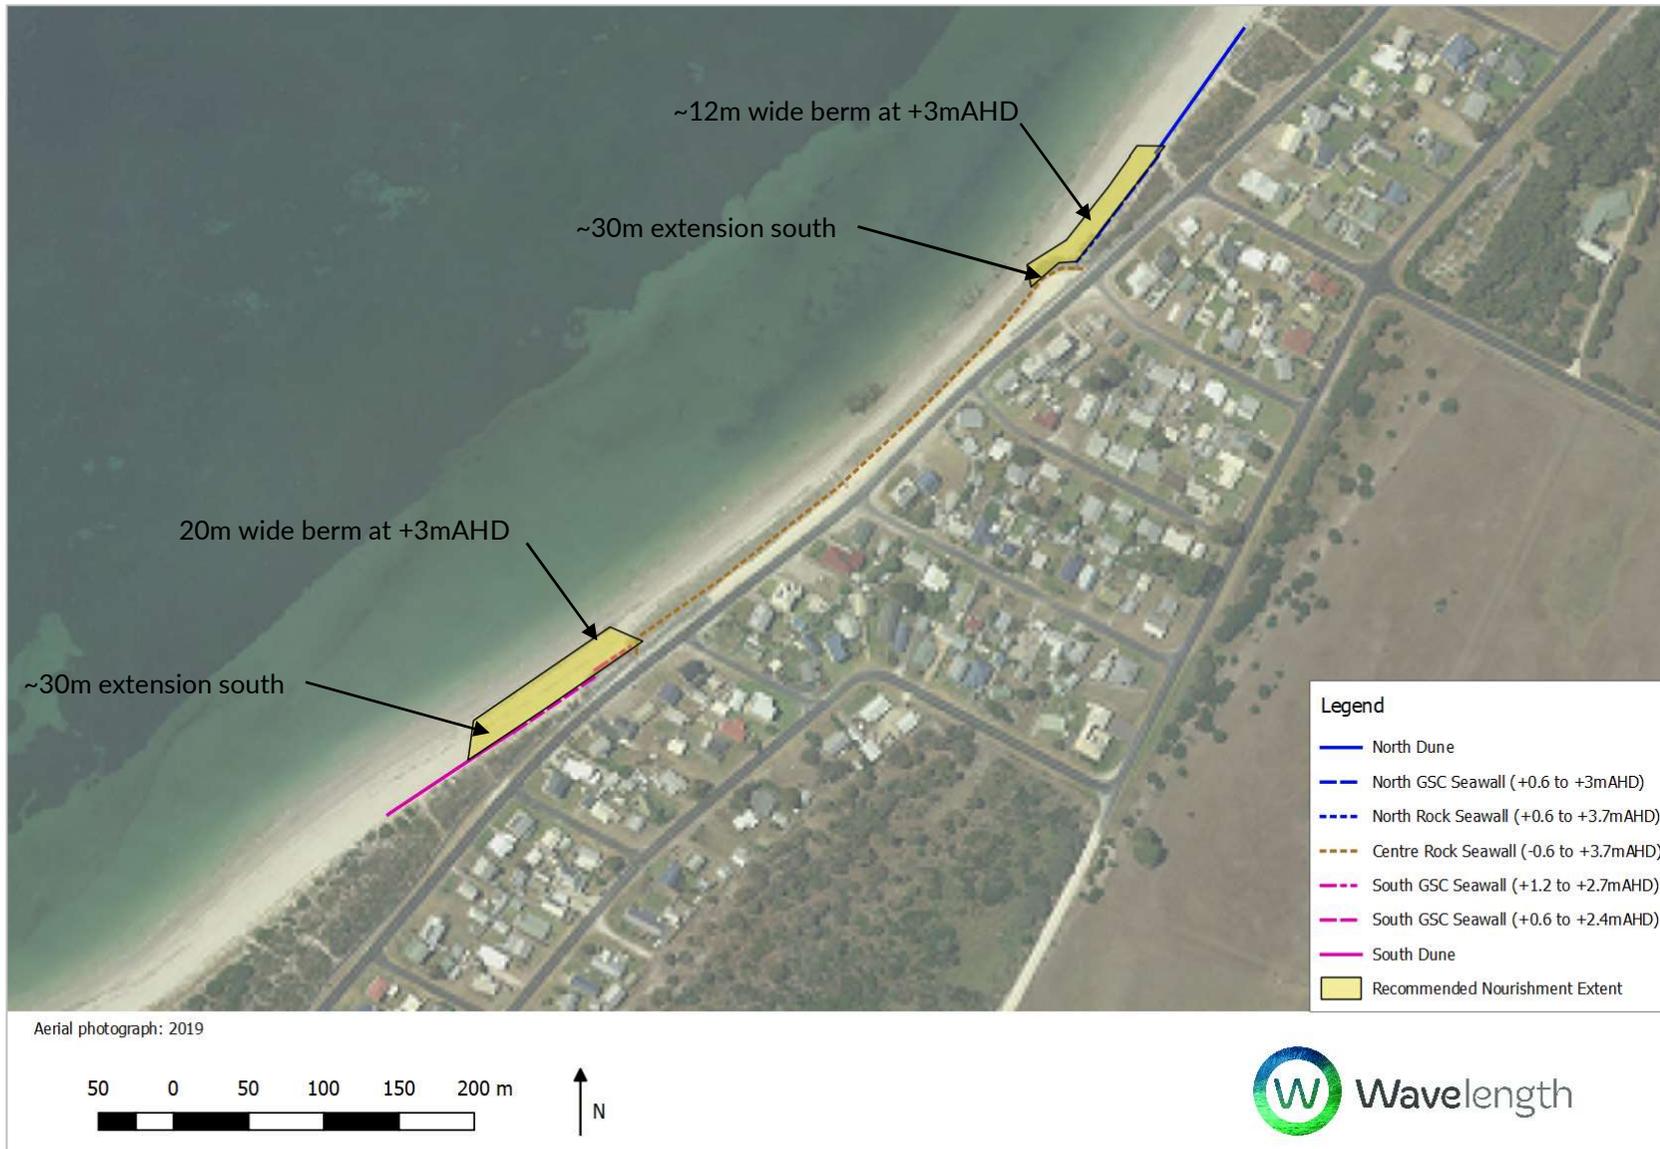
Figure 14: Recommended Nourishment Extent

- The remaining \$80,000 of Coast Protection funds should be spent on placing an additional 4,500m³ of sand nourishment in the northern compartment, as shown in Figure 13. This would equate to an approximate 120m long nourished berm with a cross-sectional area of approximately 40m³ per m. Whilst this would have a slightly reduced width compared to the design nourishment profile, it is expected to provide a suitable buffer to reduce erosion and overtopping risks in the northern compartment.
