Technical Note

Client: Kingston District Council

Subject: Wyomi Beach – 2021 Nourishment Design

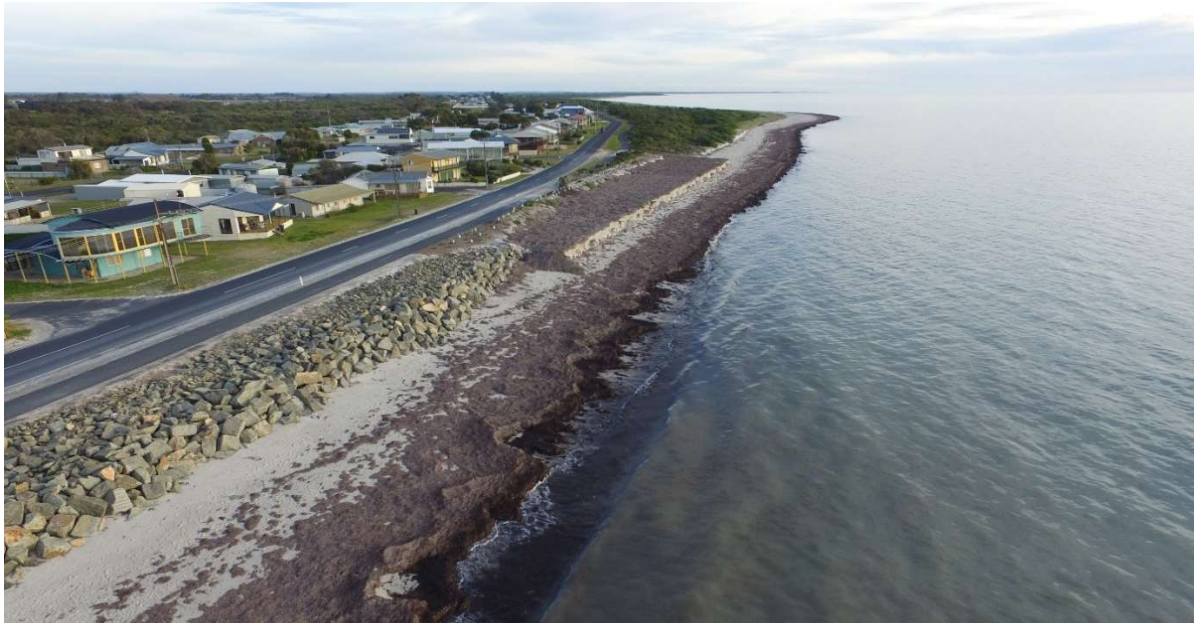
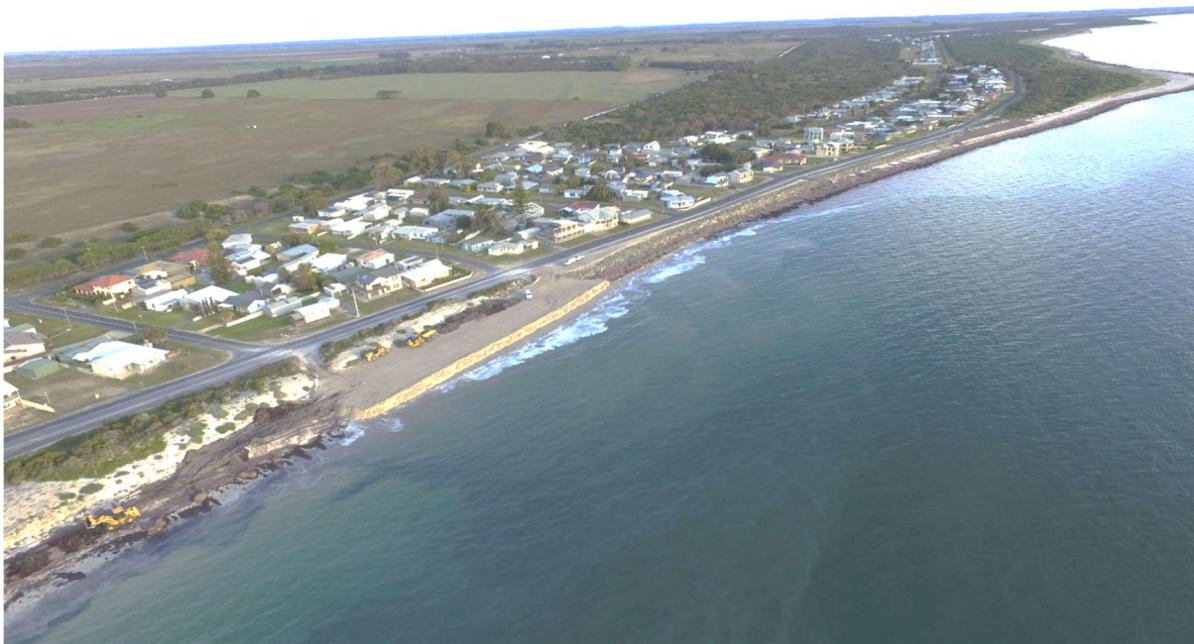
Figure 2: Southern (top) and northern (bottom) reach nourishment photographs (KDC 11 June 2020)

The 2020 nourishment works were commenced in late May 2020 and completed in mid-June 2020. Drone photographs of the placed nourishment are presented in Figure 2.

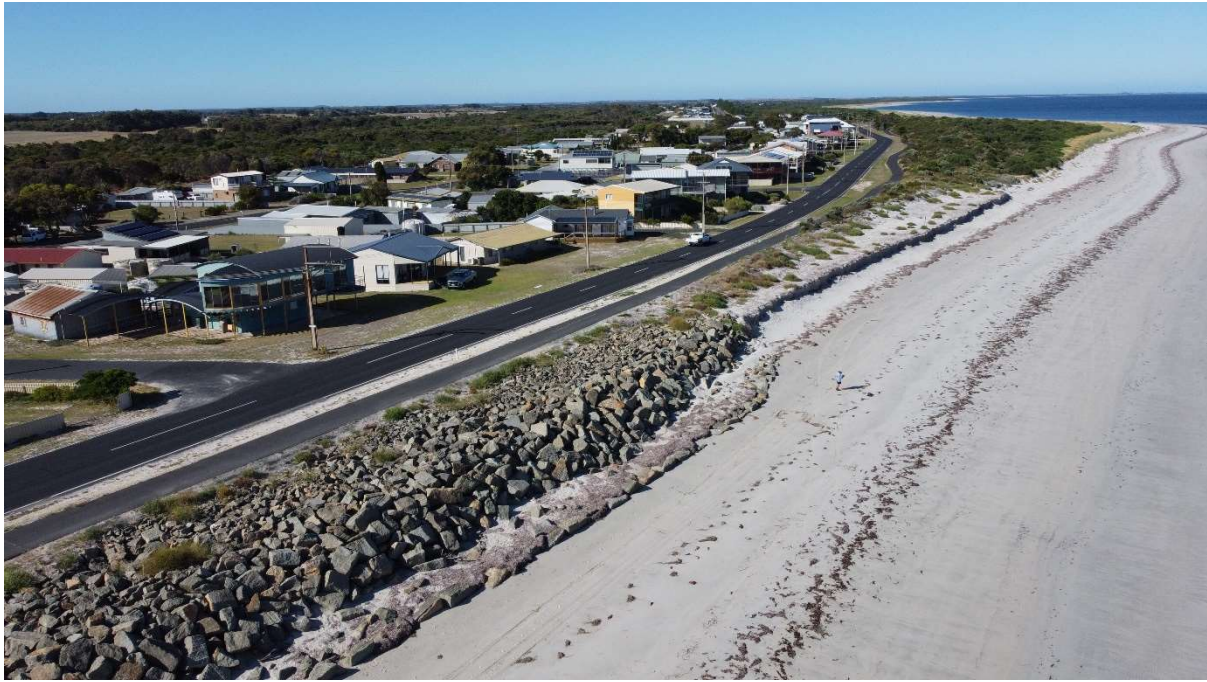
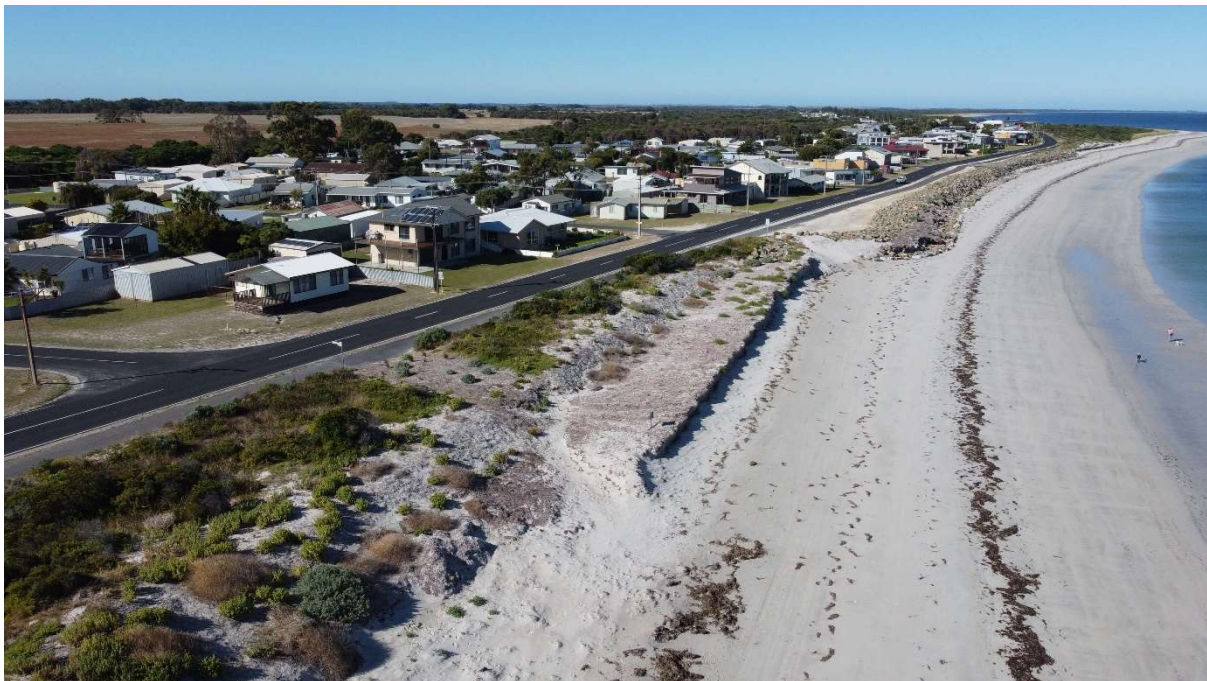
Figure 4: Drone photos of summer beach width and remaining sand nourishment: southern (top) and northern (bottom) reaches (Patrick Hesp PhD; DSc Strategic Professor in Coastal Studies, Flinders University)

Drone photos of the beach taken at low tide in early February are presented in Figure 4. These show a significant beach in front of the seawall, which has been minimal in recent years.

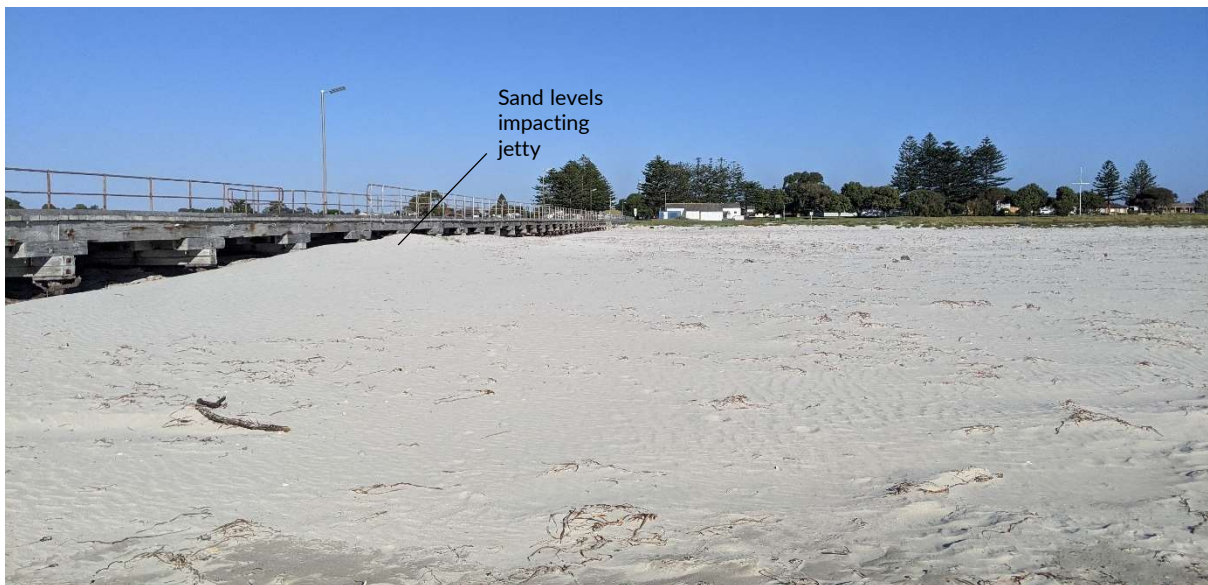
Figure 6: Nourishment source site (16 March 2021)

The 2020 nourishment campaign sourced sand from the southern side of the Kingston Jetty, approximately 3km south of Wyomi Beach. This is a problematic area of accretion, where increasing beach widths and berm levels impact on the jetty amenity. The site visit completed by Wavelength 16 March 2021 identified on-going build up of sand on the southern side of the jetty (Figure 6), impacting amenity.

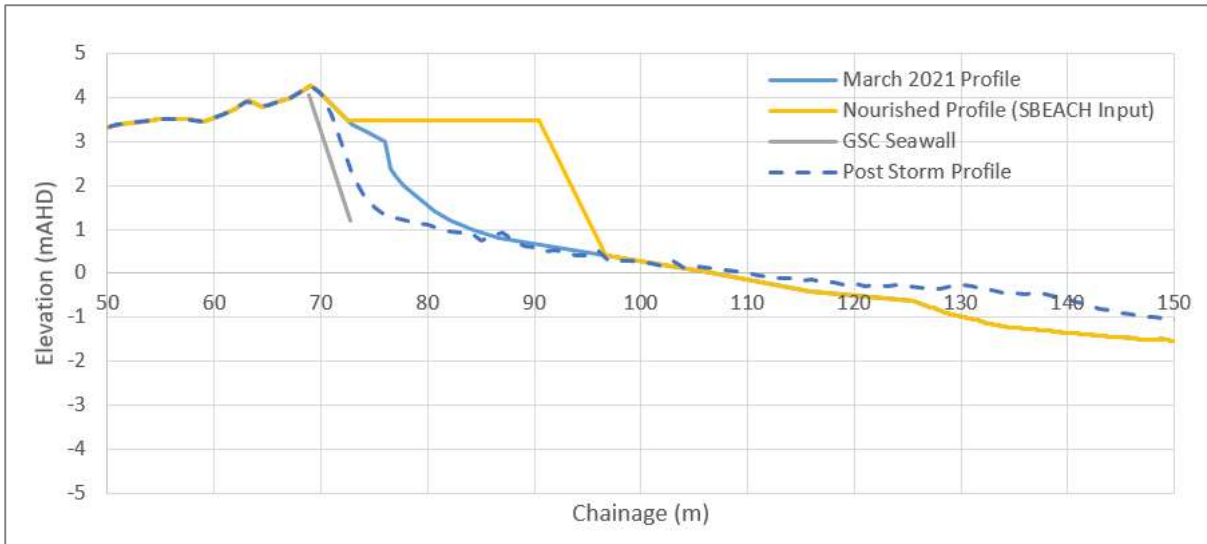
Figure 7: Southern reach SBEACH model results

- **Southern reach:** 18m wide berm at +3.5mAHD, total placed volume of approximately 45 m³ per m.
- **Northern reach:** 20m wide berm at +3.5mAHD, total placed volume of approximately 30 m³ per m.
- Seaward slope at the natural sand repose angle (approximately 1V:2H) tying into adjacent dunes and beach.

SBEACH modelling results, showing the 20 year ARI design storm outputs, are presented in Figure 7 and Figure 8. These suggest adequate protection is provided by the above design profile for the design storm event.

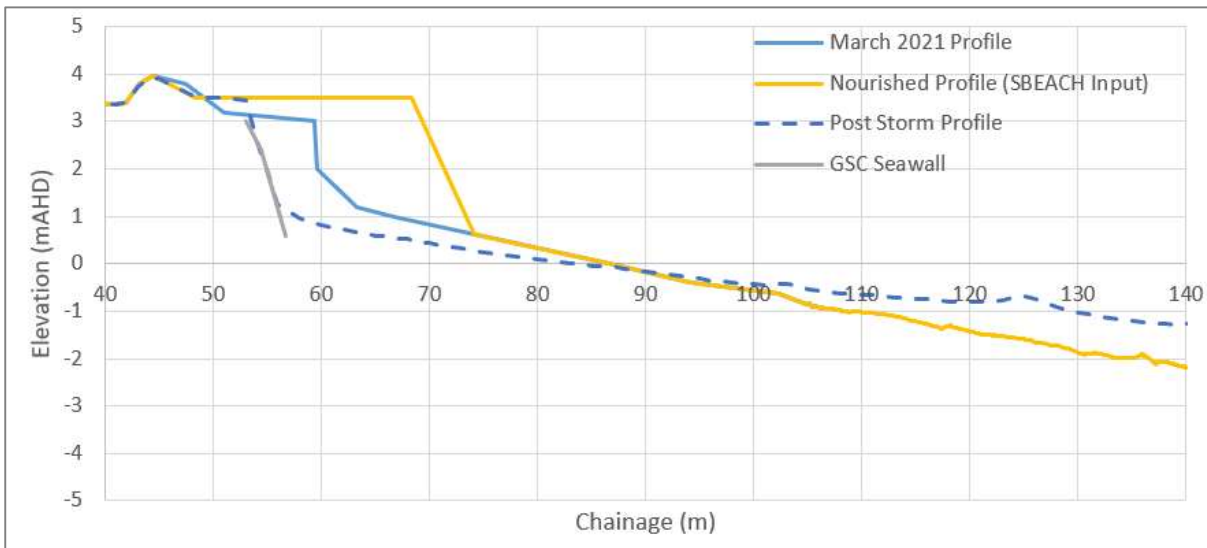
Figure 8: Northern reach SBEACH model results

- The northern GSC may become exposed in the design storm but is not expected to be undercut.
- A series of smaller storm events may have the same erosion impact as the larger design event, which may erode the protective buffer provided by the nourishment over time.
- Should the nourishment width at the critical location (i.e. 30m stretch of 0.75 m³ GSC seawall in the southern reach) narrow to less than 5m in winter, it's recommended Council place emergency sand nourishment to prevent undercutting of the seawall and erosion risk to assets. On-going monitoring of the nourishment identified in Section 3.1 would help to identify when this trigger width has been reached.
