# **Rosetown Stormwater Investigation**

## **Storm Surge Inundation Protection**

**Kingston District Council**

29 October 2025  
Ref: 251187R001RevA

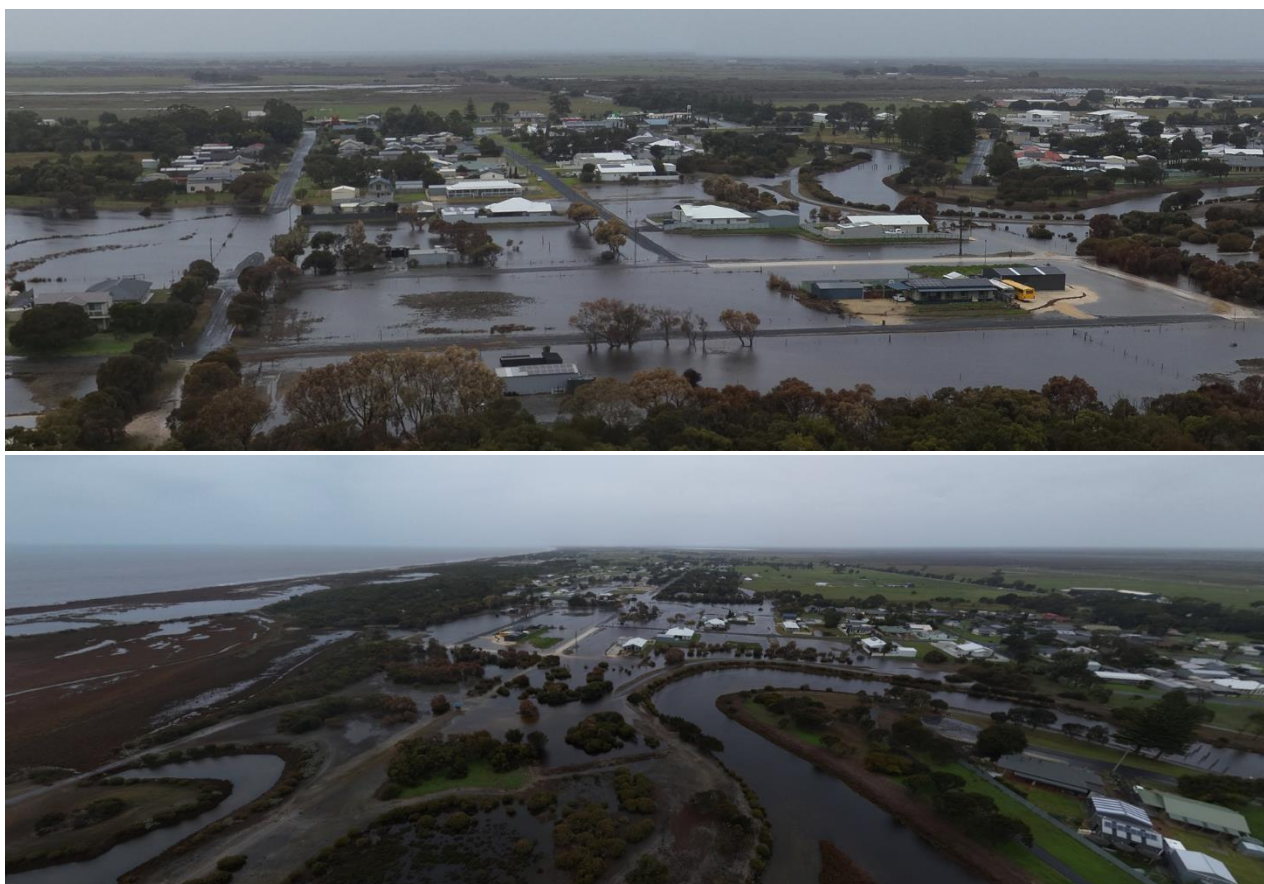
The Rosetown area has been subject to significant recent inundation due to storm surges combined with high tides, flooding the area via the Maria Creek drain. Once the area has become inundated, there is no local drainage system that is able to drain the water away which therefore results in pooled water sitting in the area for a long time after the inundation event. The inundation has also resulted in road closures. Photos from a recent storm surge event can be found in Figure 1.1 below.

**Figure 1.1 Photos from recent storm surge event in Rosetown**

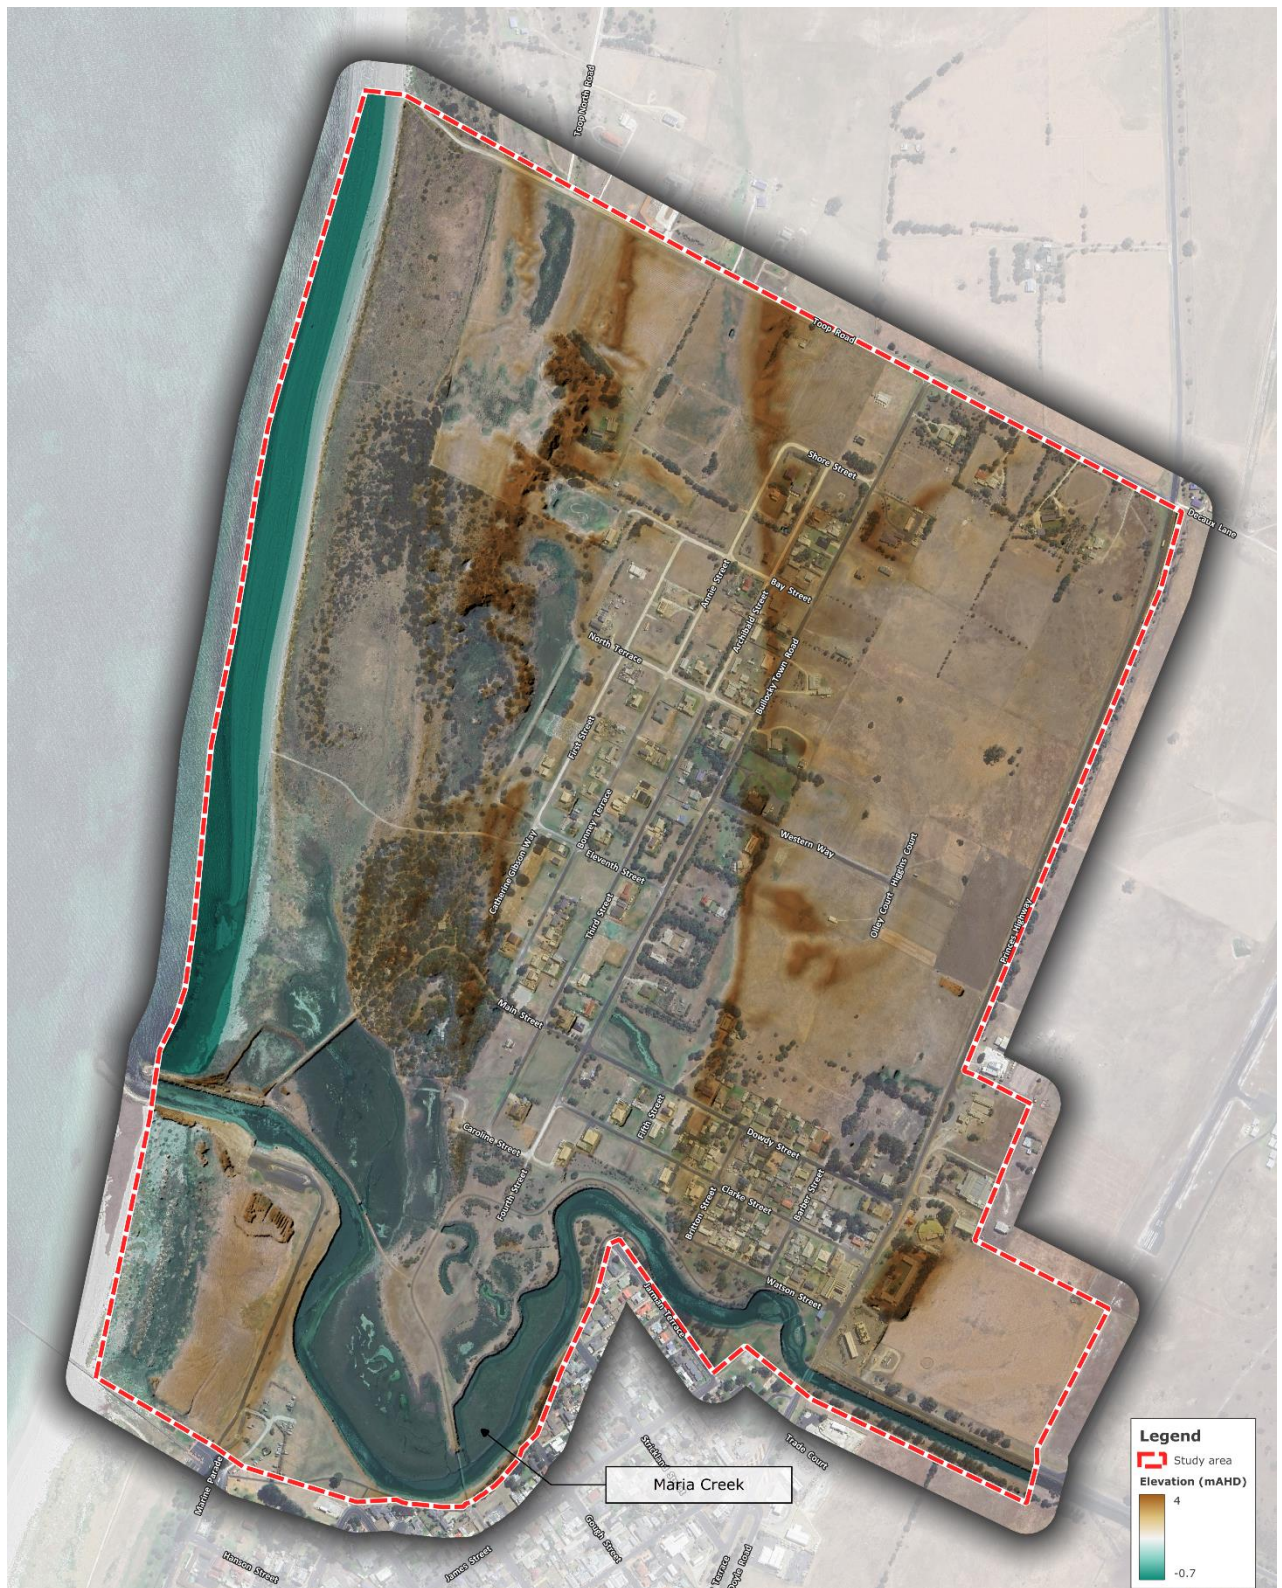
Rosetown is located just north of the main Kingston SE township and is approximately 290 km southeast of Adelaide. LiDAR based digital elevation model (DEM) for Rosetown was obtained using ELIVS, an online portal for obtaining Australian elevation data. Figure 2.1 below shows the elevation map for Rosetown. A review of the metadata files for the DEM indicate that the vertical accuracy of the elevation data is +/-15cm (95% confidence interval). The DEM shows that the urban area of Rosetown is relatively low-lying and is bounded by 2 elevated ridgelines to the east and west. There is also a swamp or marsh area located at the intersection of Dowdy Street and Bullocky Town Road. Along the northern bank of Maria Creek, the DEM indicates that there is an elevated earthen levee with levels between 1.4 mAHD to 2.2 mAHD.

Figure 2.1 Elevation map of Rosetown

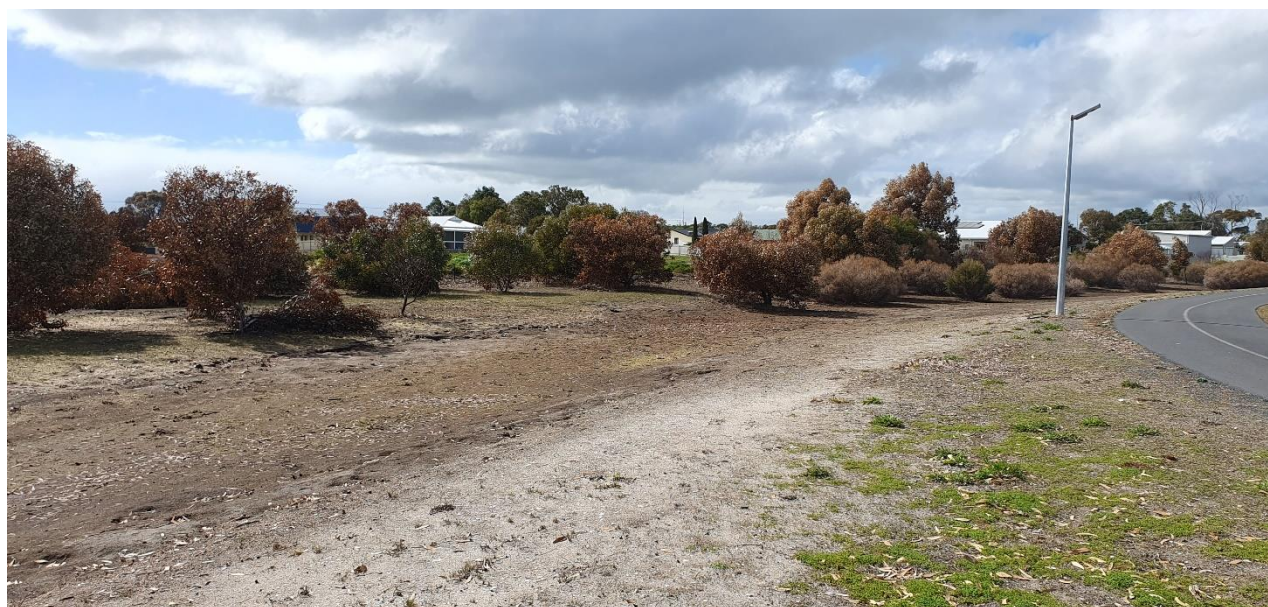
There are two main areas where Council estimates the storm surge breaches the northern bank of Maria Creek to inundate Rosetown. These are denoted as location A and location B in Figure 2.2. At location A, the storm surge propagating up Maria Creek would likely result in wave action pushing water over the earthen levee and raised shared path into Rosetown. A photo taken of the raised shared path can be found in Figure 2.3.

**Figure 2.3 Elevated shared path on northern side to Maria Creek**

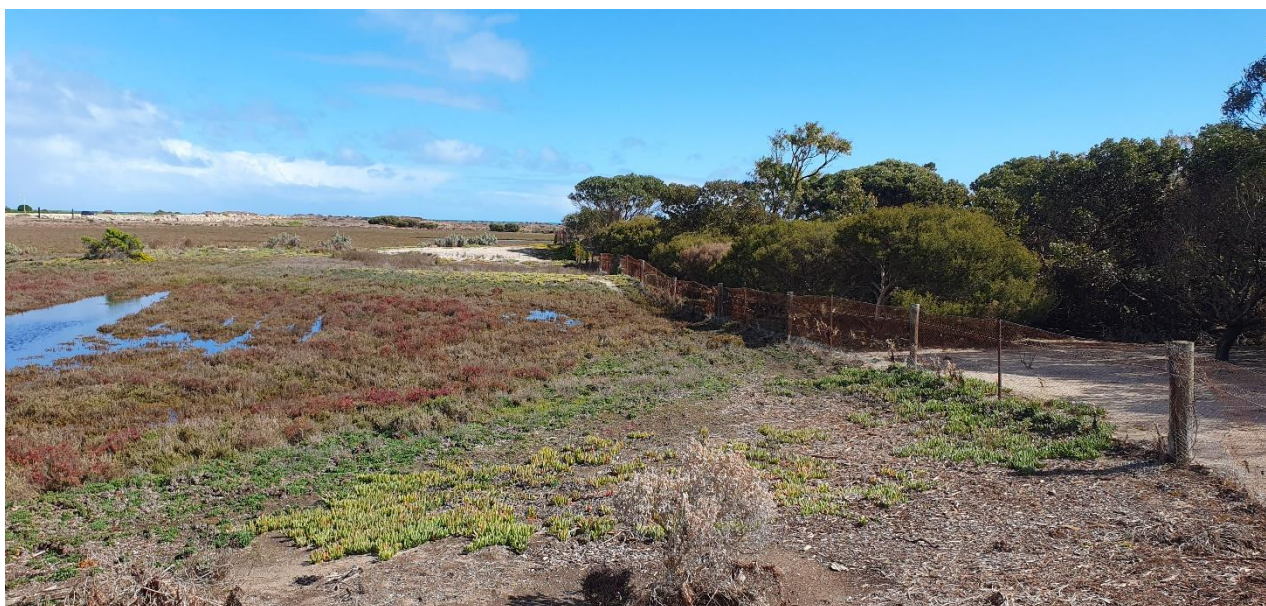
At location B, Council observed that the storm surge caused water to overtop the ridges located to the west of Third Street. Inundation of the heritage area located to the west of Rosetown was also reported to Council. During the site visit, a depression in the terrain which encourages flows through the heritage area was noted. This area is denoted as location C in Figure 2.2 and a photo of this depression can be found in Figure 2.4. It should be noted that this depression has also been captured by the DEM.

**Figure 2.4 Floodplain adjacent to heritage area**

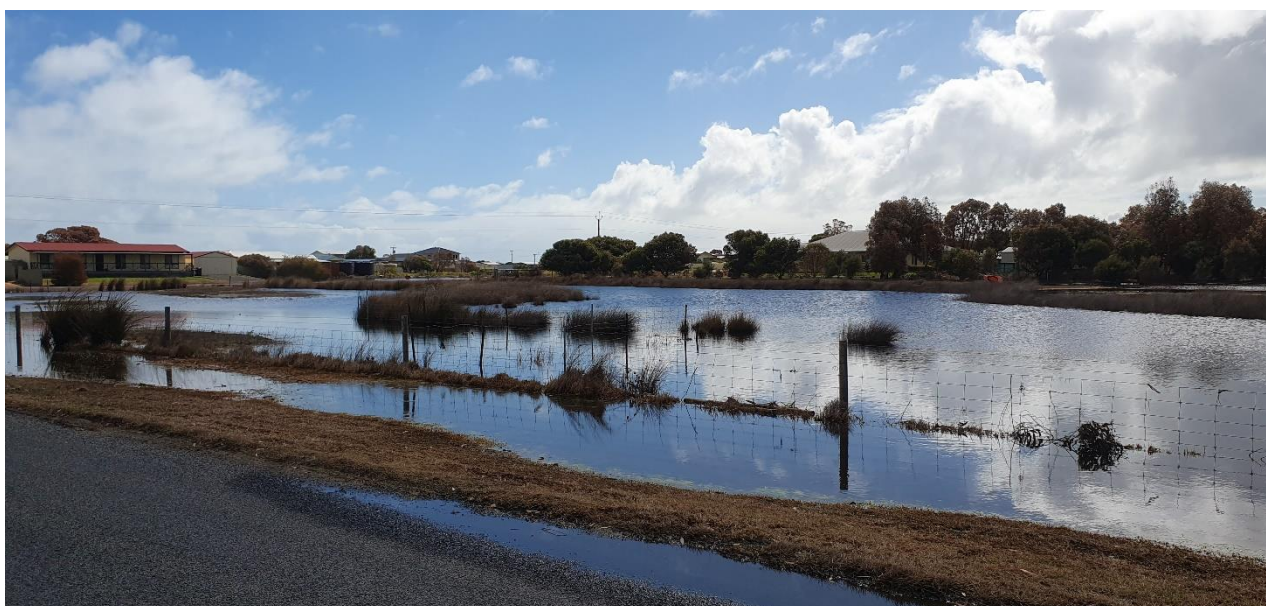
**Figure 2.5 Low lying area adjacent to Dowdy Street**

The land parcel at the corner of Dowdy Street and Bullocky Town Road currently contains a depression approximately 0.8–1.0 m deep that is landlocked. As shown in Figure 2.5, this area remains fully inundated following the storm surge event, with infiltration and evaporation being the only means of water removal. Because it lies lower than the surrounding land, this area could be formalised as a wetland. The indicative wetland footprint, shown in Figure 4.6, is approximately 1.1 ha. If excavated to a minimum depth of 0.8 m, the wetland could provide a total storage volume of about 8,000–9,000 m<sup>3</sup>, a substantial increase over the current estimated capacity of 2,600 m<sup>3</sup> (up to 1.3 mAHD, based on the DEM).
